Development of a NDT method using thermography for composite material inspection on aircraft using military thermal imager

By : P. Servais¹ and N. Gerlach²

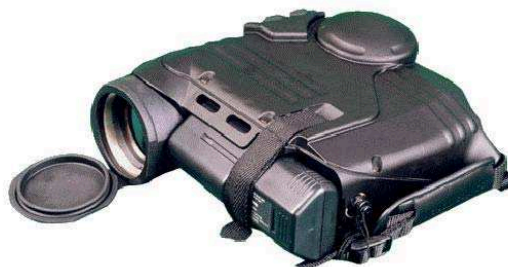
Figure 1 : military Thermal imager used by Belgian Defense

TNDT (Thermal Non Destructive Testing) is now an emerging method that comes out of laboratory since a few years. It is here proposed to investigate, compare and quantify the different possibilities to use thermography instead of radiography or ultrasonic testing on composite parts in maintenance of military aircrafts. The new idea is to use military thermal imagers also used by the infantry (see figure 1) because the detector is now an infrared focal plane array capable of measuring a very faint difference of temperature (less than 0.07 K)

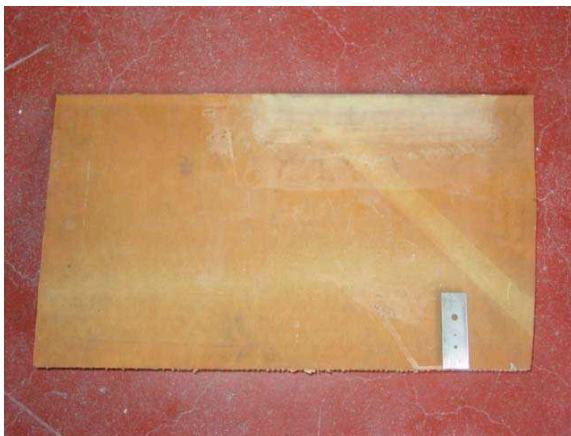
Figure 2 Left : composite part with hole type IQI,

Right : thermal image of composite part with water ingress

- porosity which reduces the compressive load carrying capability,
- water ingress or moisture which can degrade the mechanical properties of some resins or lead to freeze inside the part causing more and more damage (see picture 2 for honeycomb composite part with central view of hotter area in the centre of the piece viewed in white in picture 2)
- disbond or delamination resulting from low strength in the resin
- impact damage during the taxi or caused by bird strike or by a dropped tool during maintenance
- inclusions which can reduce strength by kinking the fibres around the inserted material

Some defects like water ingress cause high thermal difference on the surface as seen on Fig 2 below. This thermal difference depends on their characteristics, their dimensions and their depth in the piece part. So the camera should have good thermal resolution (NETD or Noise Equivalent Temperature Difference). [2] Recent work made by Italian Air Force showed that 0.1 ml water ingress in one cell of honeycomb flap of AMX aircraft could show a thermal difference of 1°C when surface is heated with a flow of 15000 W/m². [3]

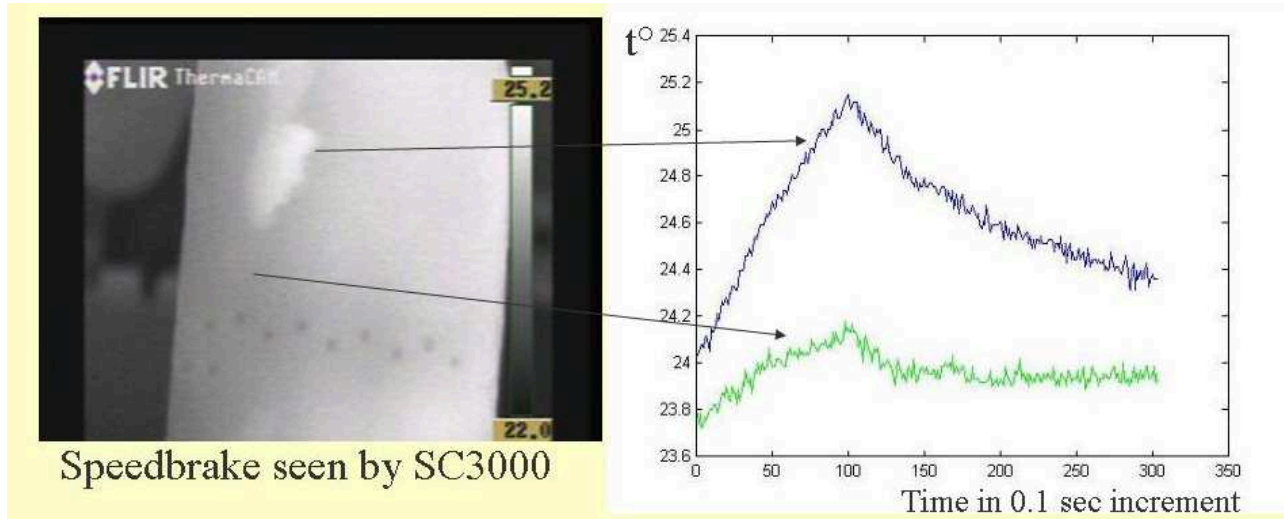
Figure 5 : Alphajet speedbrake tested with FLIR camera with T° evolution during 30 sec on 2 relevant points
